**3'/E91/Sports**

**Wagon/320d/N47/AUTO/ECE/LL/2009/04**

**63 13 080**

**Removing and  
installing/replacing left  
direction indicator insert  
from series status 09/2008**

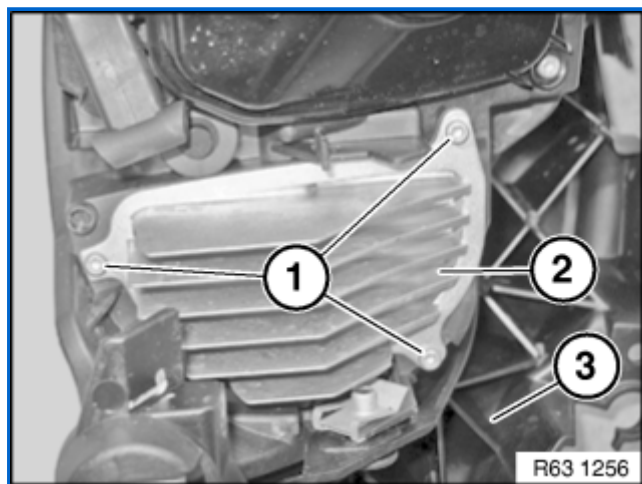
Release screws (1).

Tightening torque [63 12 9AZ](#) .

Remove direction indicator insert (2) from headlight (3).

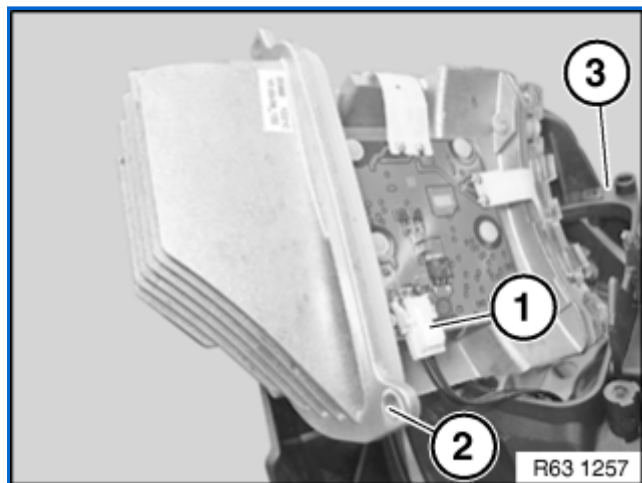
Unfasten plug connection (1) and disconnect.

Remove direction indicator insert (2) from headlight (3).
